CASE STUDY: EAGLE CREST, IRVING, TEXAS

Steve Gregory and Jim Roberson

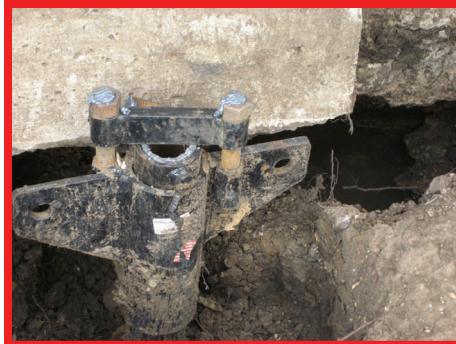
The slab floor did not have sufficient strength to completely bridge between the piers on the load-bearing walls. A wide flange steel beam (see picture to right) was welded to the horizontal arm of the pier bracket. This was welded in place after the pier was set up but before pier driving began.

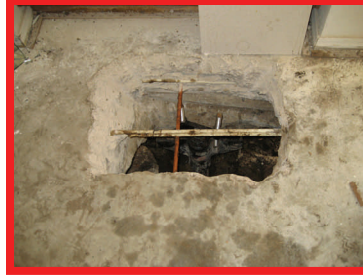
Post-tension cables can be observed through many of the access holes in the slab floor (see picture at left). These cables should be tensioned to within 90% of their yield strength or around 27,000 lbs. for a 1/2" cable. Some of the cables can be seen to be loose and have slack in

them. The purpose of the cables is to keep the concrete rigid by exerting compression forces into the concrete through tension. A rotary drill and pavement breaker were used to create the access holes through the slab. This method was chosen to prevent the possibility of cutting through the cables while creating the access holes.

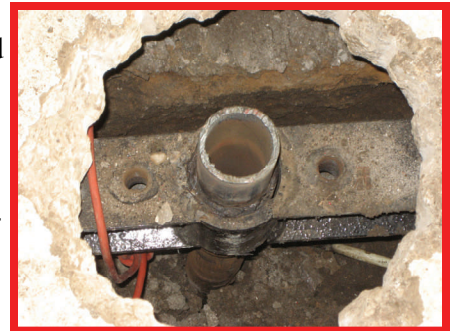
The lift on the 60 ft. by 150 ft. building was accomplished with 135 hydraulic jacking systems while being carefully raised si-

multaneously as required for a uniform lift. During the lifting process elevations were carefully monitored and documented after each selective lift phase.
