CASE STUDY: EAGLE CREST, IRVING, TEXAS

Steve Gregory and Jim Roberson

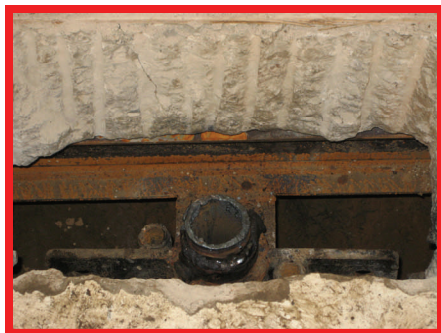
Post-tension cables can be observed through many of the access holes in the slab floor (see picture at left). These cables should be tensioned to within 90% of their yield strength or around 27,000 lbs. for a 1/2" cable. Some of the cables can be seen to be loose and have slack in

them. The purpose of the cables is to keep the concrete rigid by exerting compression forces into the concrete through tension. A rotary drill and pavement breaker were used to create the access holes through the slab. This method was chosen to prevent the possibility of cutting through the cables while creating the access holes.
